An Architectural Analysis and Earthen Finish
Characterization of Cavate M-100, Frijoles
Canyon, Bandelier National Monument,
Los Alamos, NM

A THESIS

Historic Preservation

2001

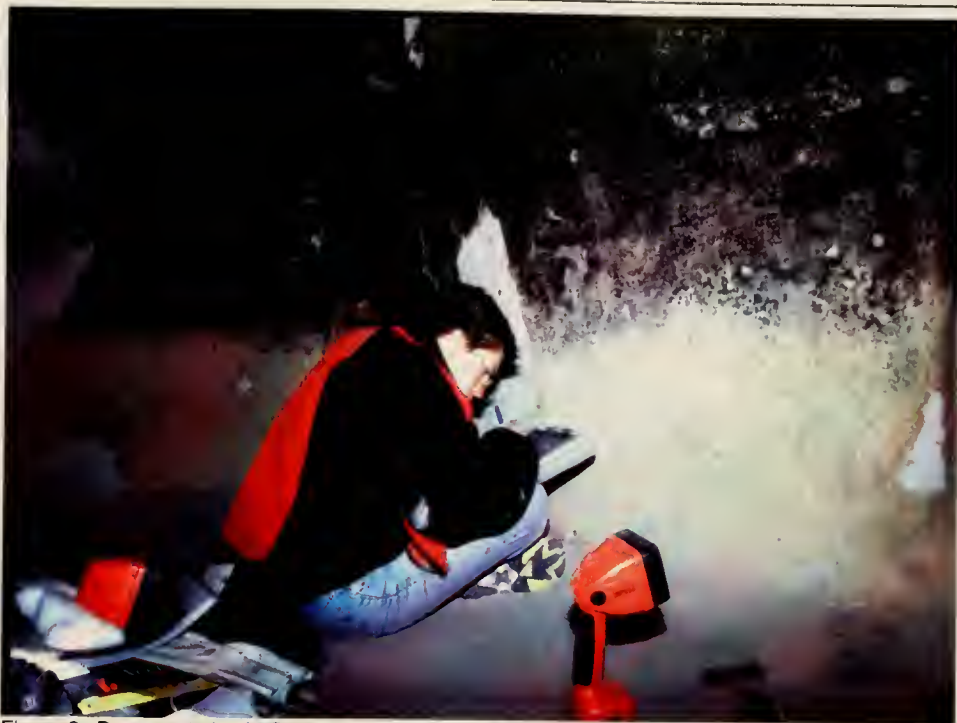
Figure 6. Documentation in Cavate M-100, Frijoles Canyon, Bandelier National Monument. Photograph courtesy Frank G. Matero.

The first step of survey was to prepare a condition assessment form for the space. The objectives of this survey were to identify and describe the existing architectural fabric; to record the condition of the cavate and its features as a baseline for monitoring and planning future conservation work; to identify threats to the current condition and integrity of the resource; to determine treatment urgency and recommend treatments; and to provide information needed to prepare a long-term preservation and management plan for the cavates.³⁸ (See Figure 6)

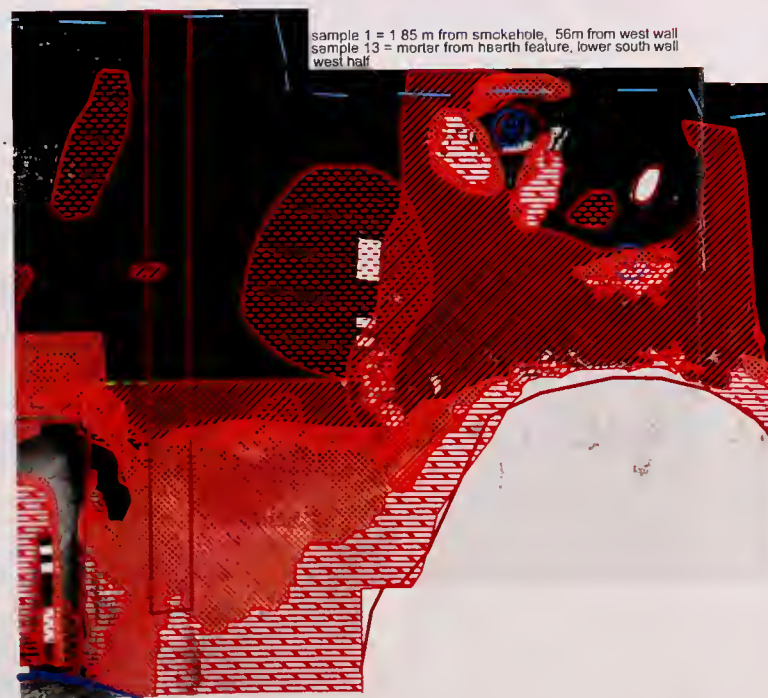
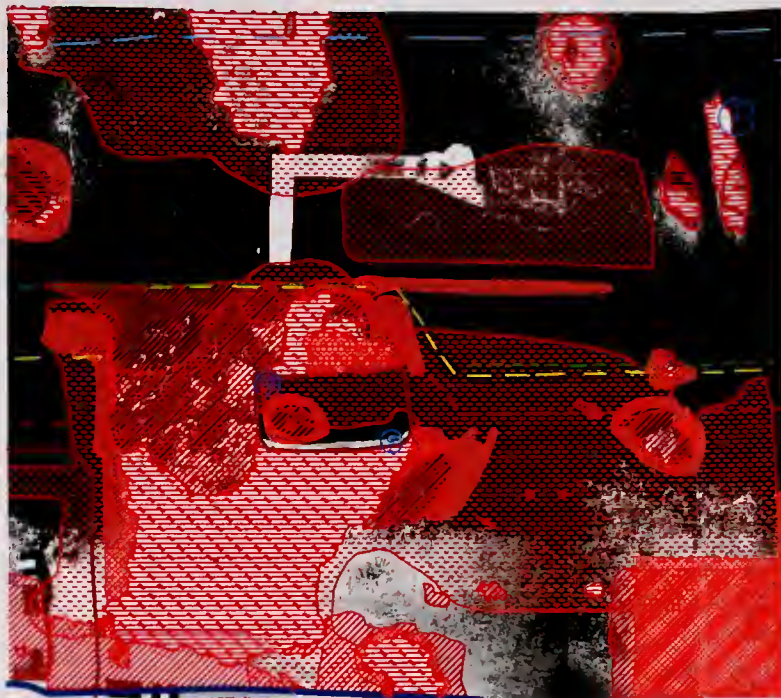
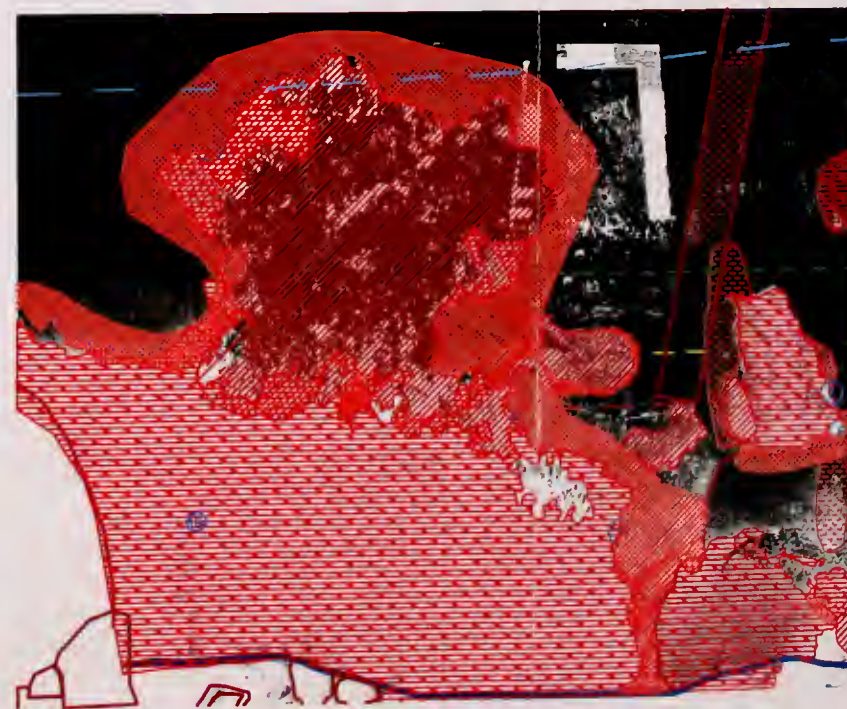
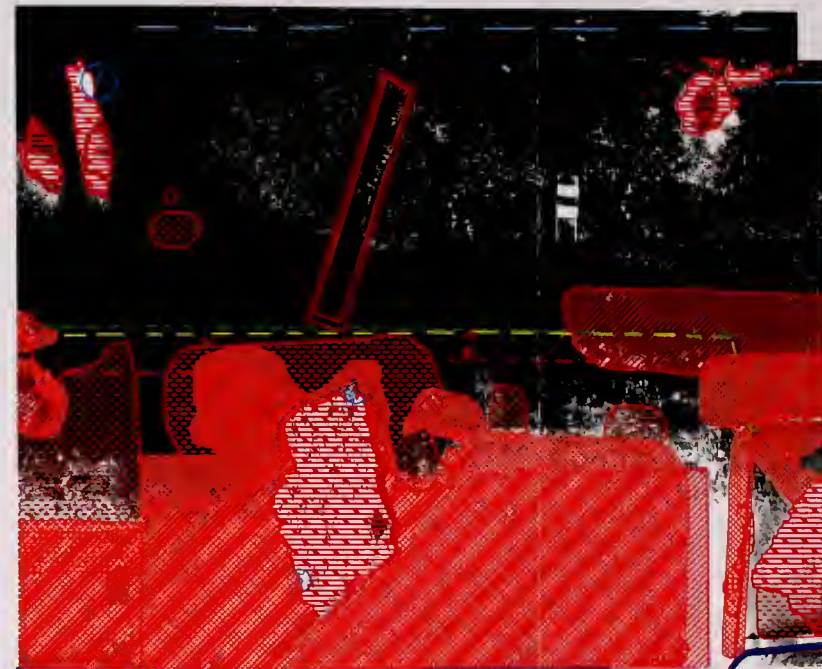
CAVATE M-100, GROUP M, FRIJOLES CANYON

Notes: Total loss, partial loss, detachment and delamination.

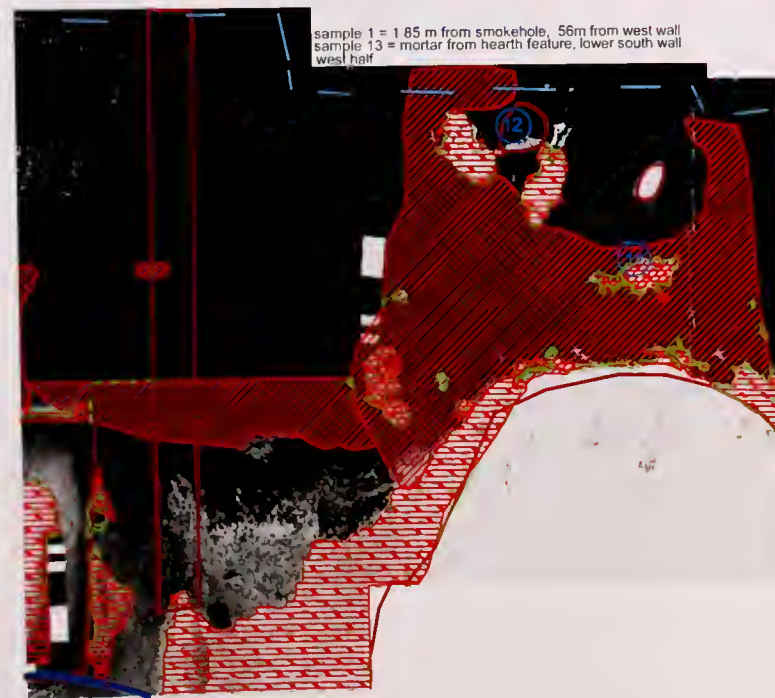
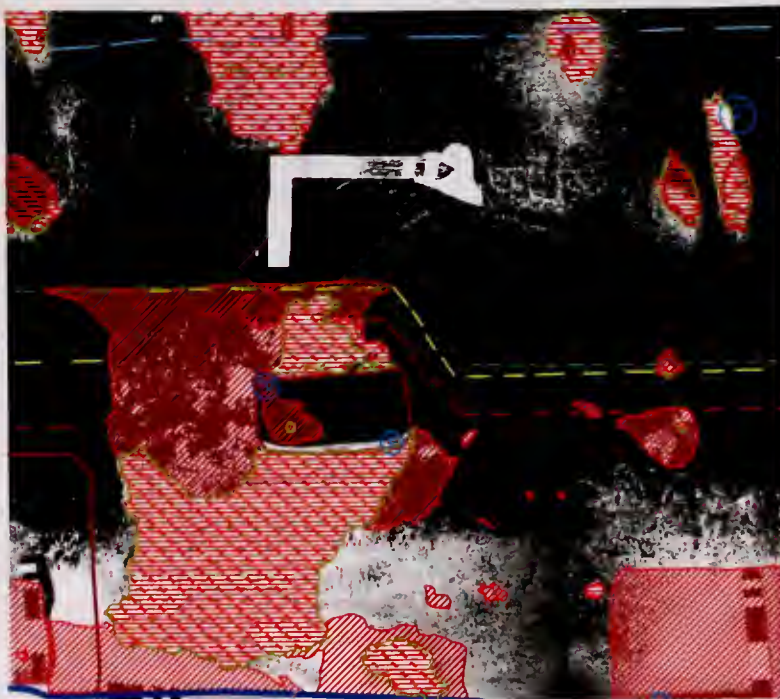
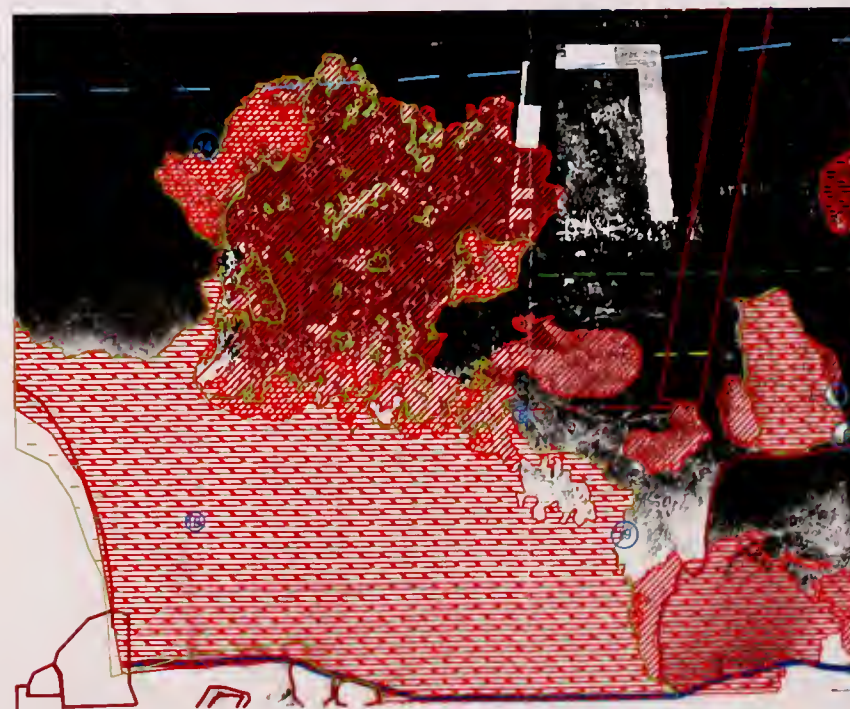
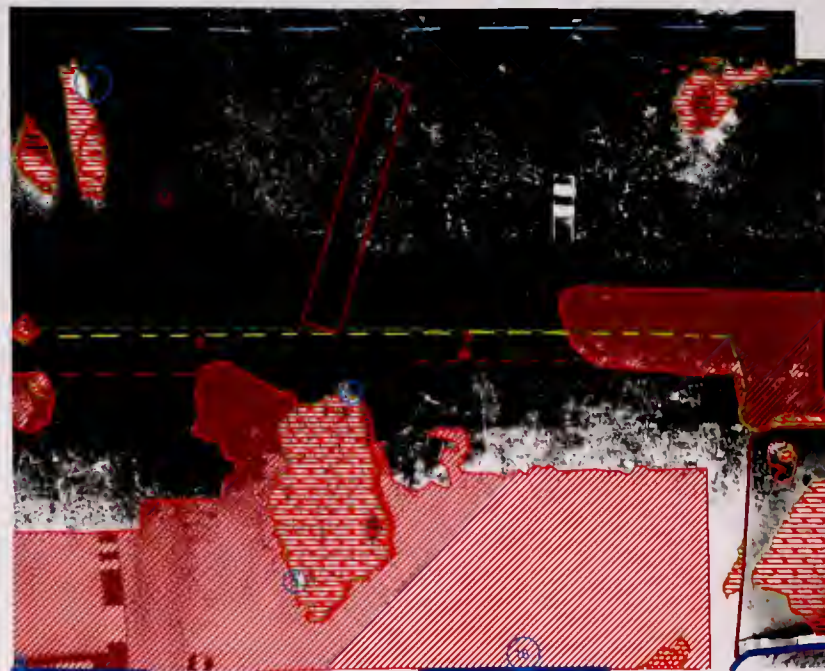
CAVATE M-100, GROUP M, FRIJOLES CANYON

Notes: Total loss, partial loss, and disaggregation.

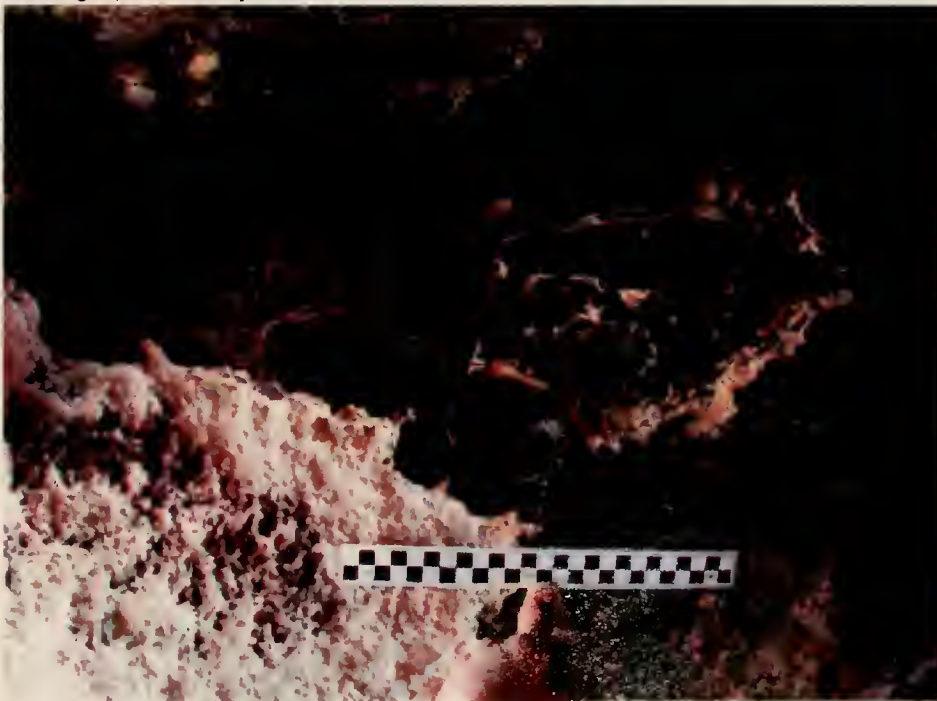
Figure C.2 Matthew J. Leibmann. June 24, 2000. West Wall, Sector 4, Panel A.
Photograph courtesy of Matthew J. Leibmann.

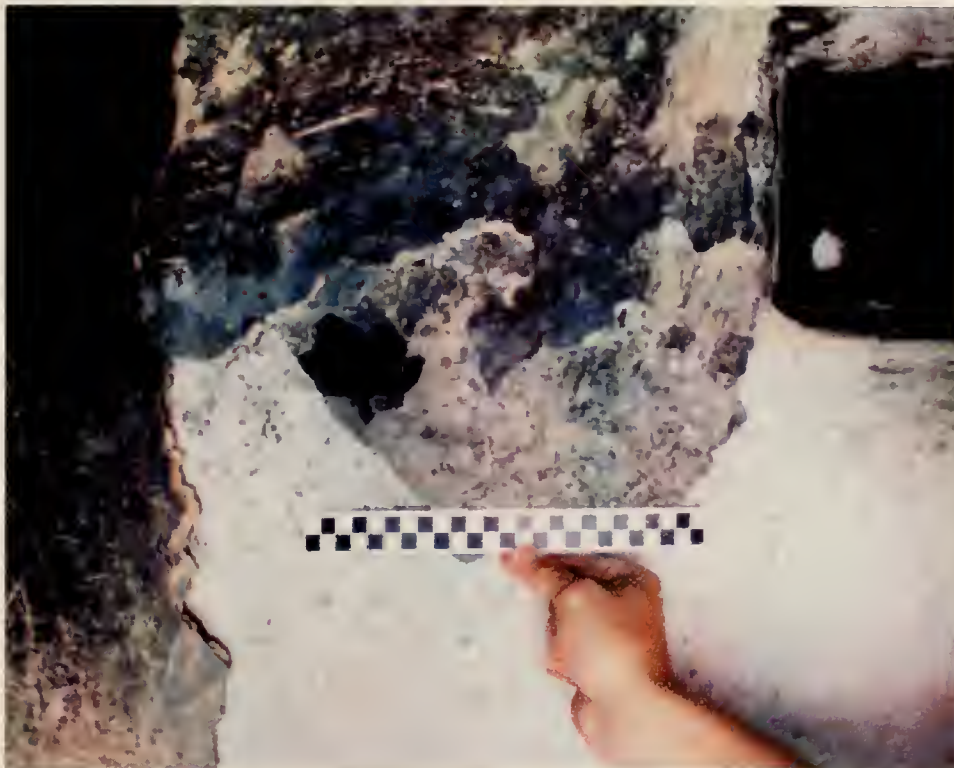
Figure C.9 Matthew J. Liebmann, June 24, 2000. Detail, Sector 8, Panel E. Photograph courtesy of Matthew J. Liebmann.

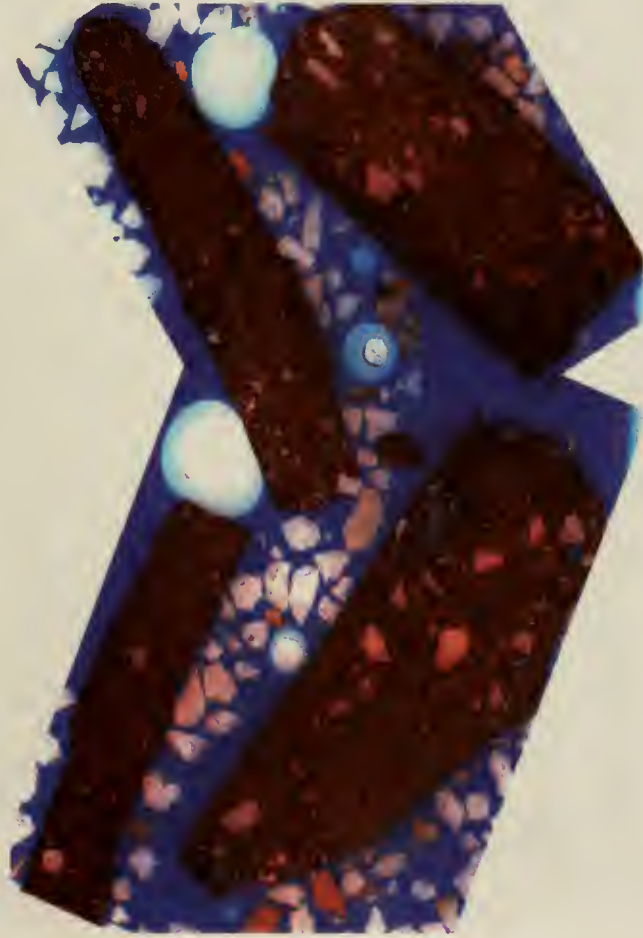
Sample BAND M-100.02

East Wall,
North Half
1.60 m from floor
.29 m from
north wall
125

There are large inclusions in layers 2, 4, 6, 8, 10, 18,
and 20.

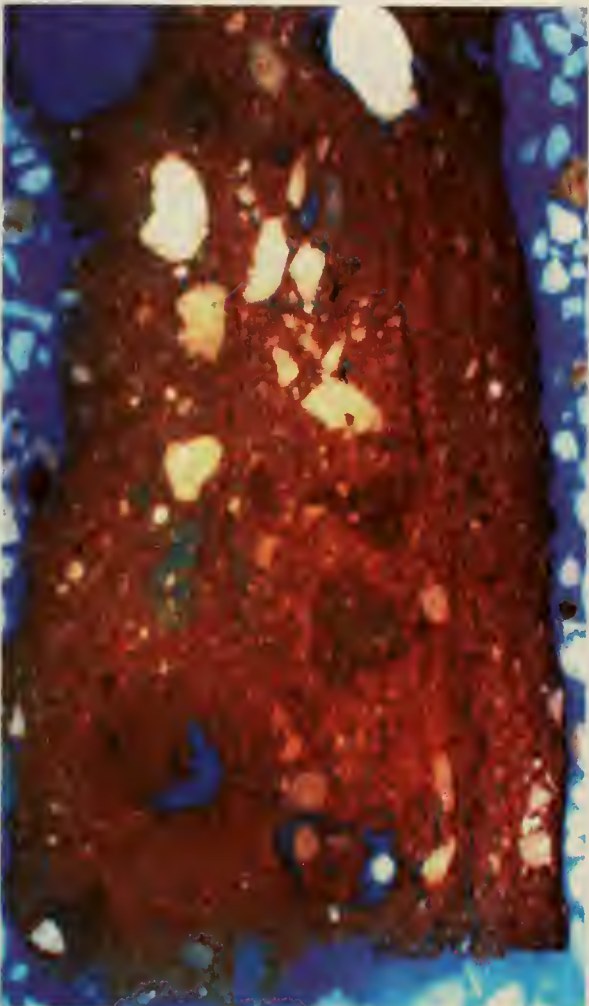
Sample BAND M-100.06

There are large inclusions present
in layers 2, 4, 10, 12, and 14.

West Wall,
North Half
.78 m from floor
.41 m from
west wall
134

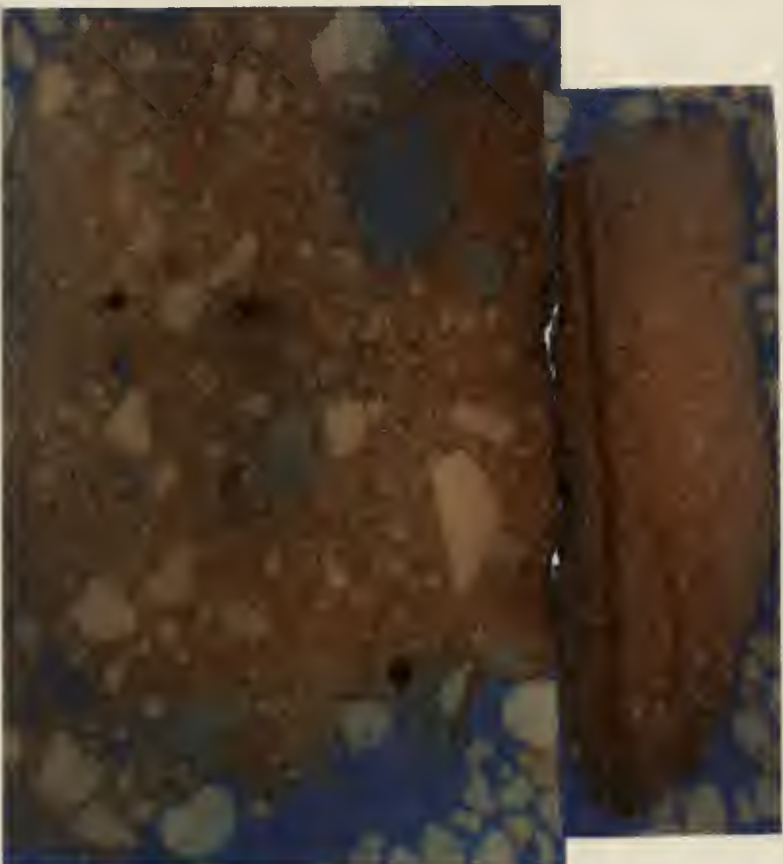
Sample BAND 100.09
Cavate M-100
Frijoles Canyon
Bandelier National Monument
New Mexico, USA

Large inclusions present in layer
9. This sample was broken, and
has been digitally reconstructed.

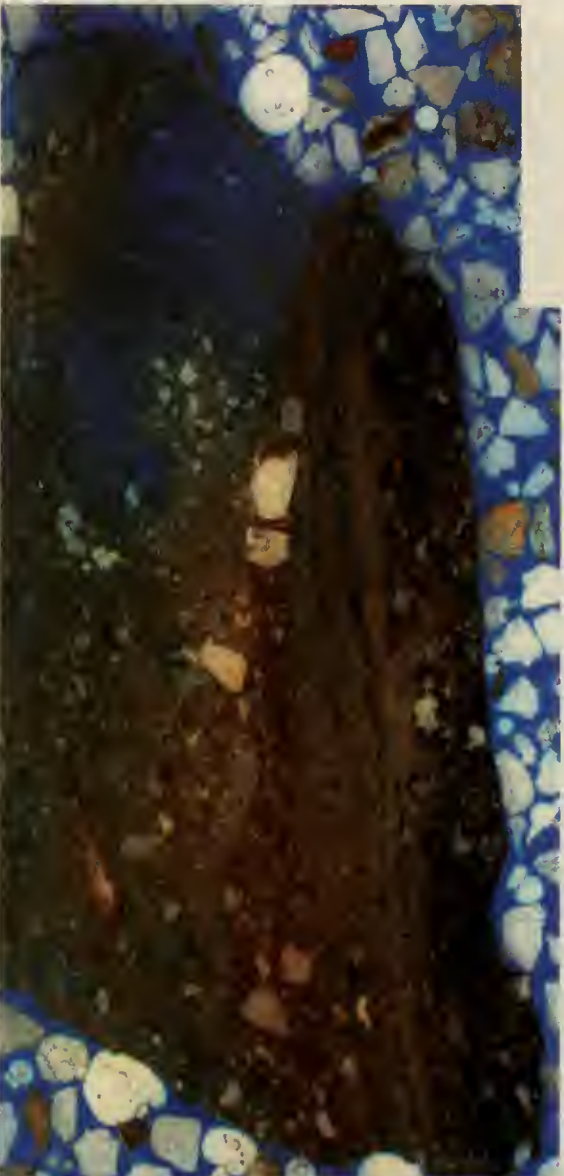
Sample BAND M-100.15

There are large
inclusions present in
layers 1, 2, 3, 13, 15,
and 17.

Lower North Wall,
East Half
Floor Sample
17 cm from
East Wall
149

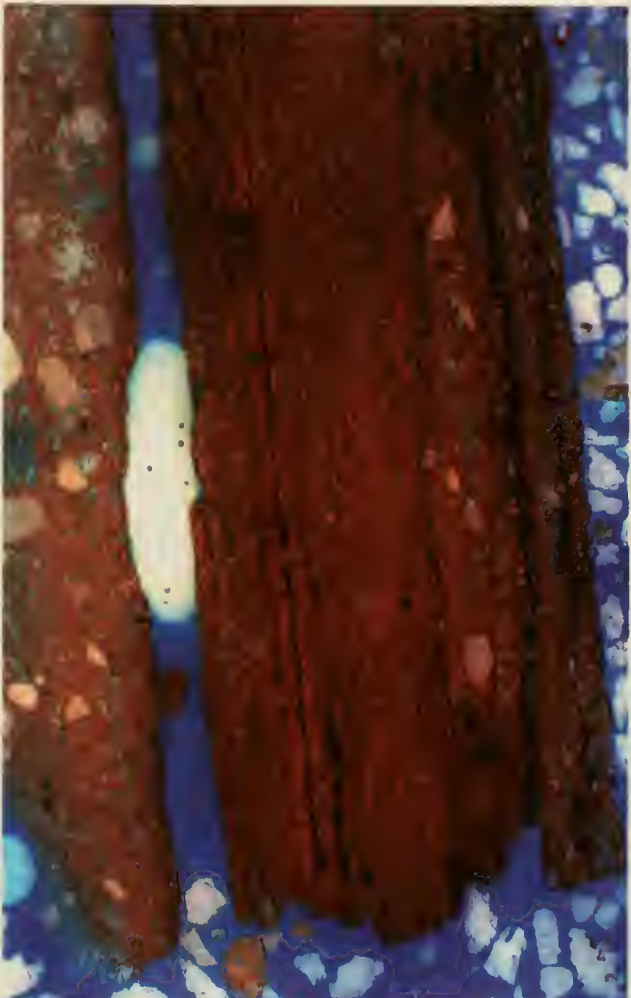
Sample M-100.19

There are large inclusions present
 in layers 4, 12, 16, and 40.

Lower West Wall,
 South Half
 30 cm from floor,
 1.46 m from door
 153
